A Multisensory Analysis of the Moisture Course of the Cave of Altamira (Spain): Implications for Its Conservation

Vicente Bayarri ^{1,2}, Alfredo Prada ³, Francisco García ^{4,*}, Carmen De Las Heras ³ and Pilar Fatás ³

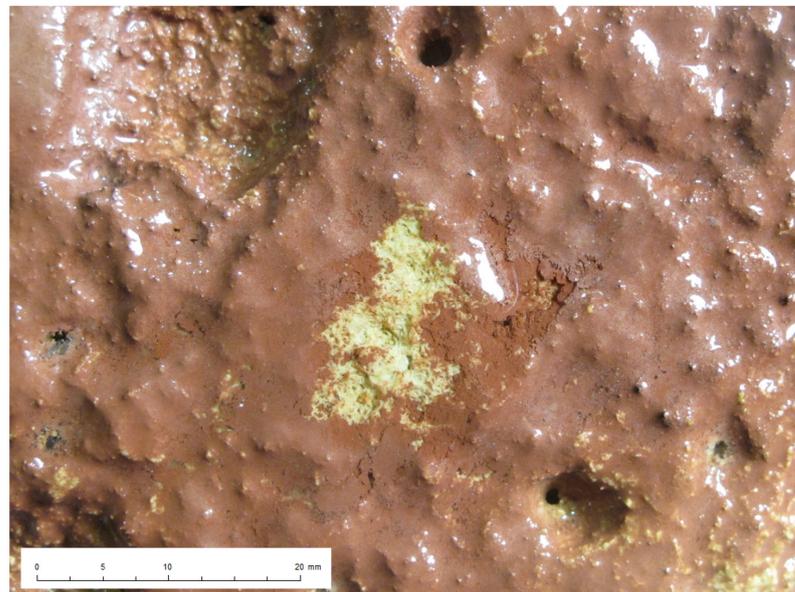
Figure 2. Image showing the microcorrosion of the supporting rock and the craquele of the pigment. Note that white areas are produced by light glints so no information is available.

CO₂, along with water, plays an important role in the dissolution and entrainment processes of the supporting rock (Figure 2). We are concerned with various deterioration processes, including microcorrosion, adhesion loss, cracking, washing, and loss of support. These processes have been in motion since the cave's inception and continue to this day. It is important to emphasize that these deterioration processes start from the moment the Altamira art was crafted.

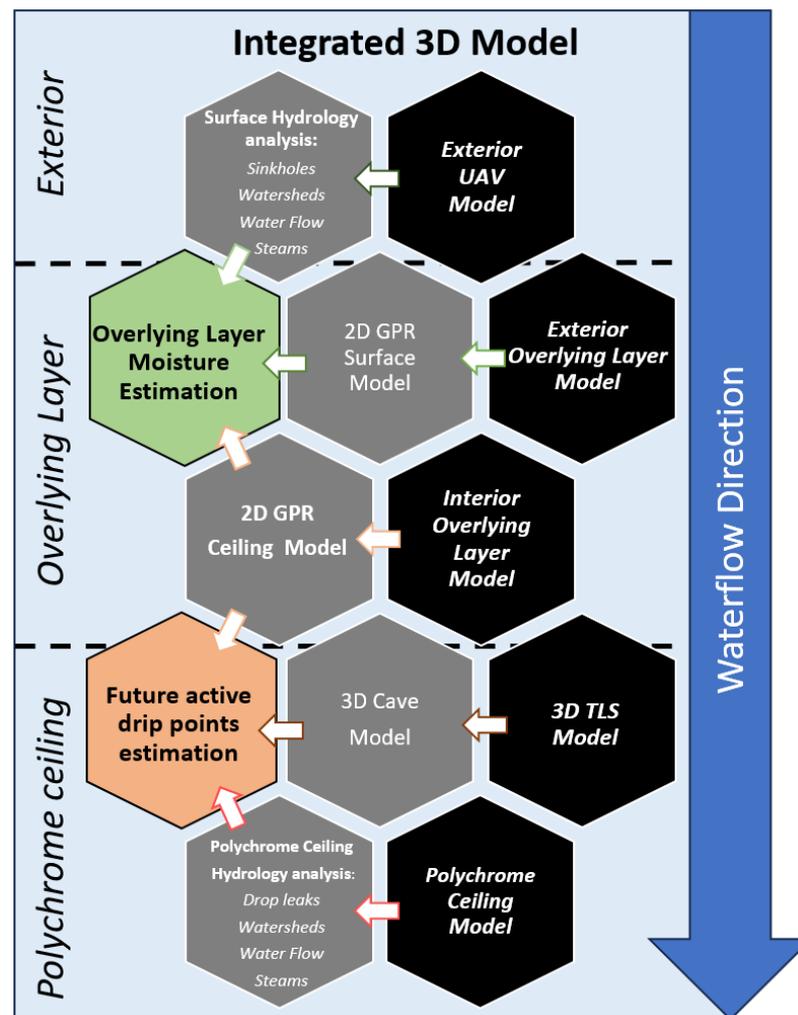
Figure 3. General workflow scheme followed in this study (adapted from [41,42]). The black hexagons indicate the integrated models, the gray hexagons the analysis performed on the models and the colored hexagons the analysis performed from the previous ones.

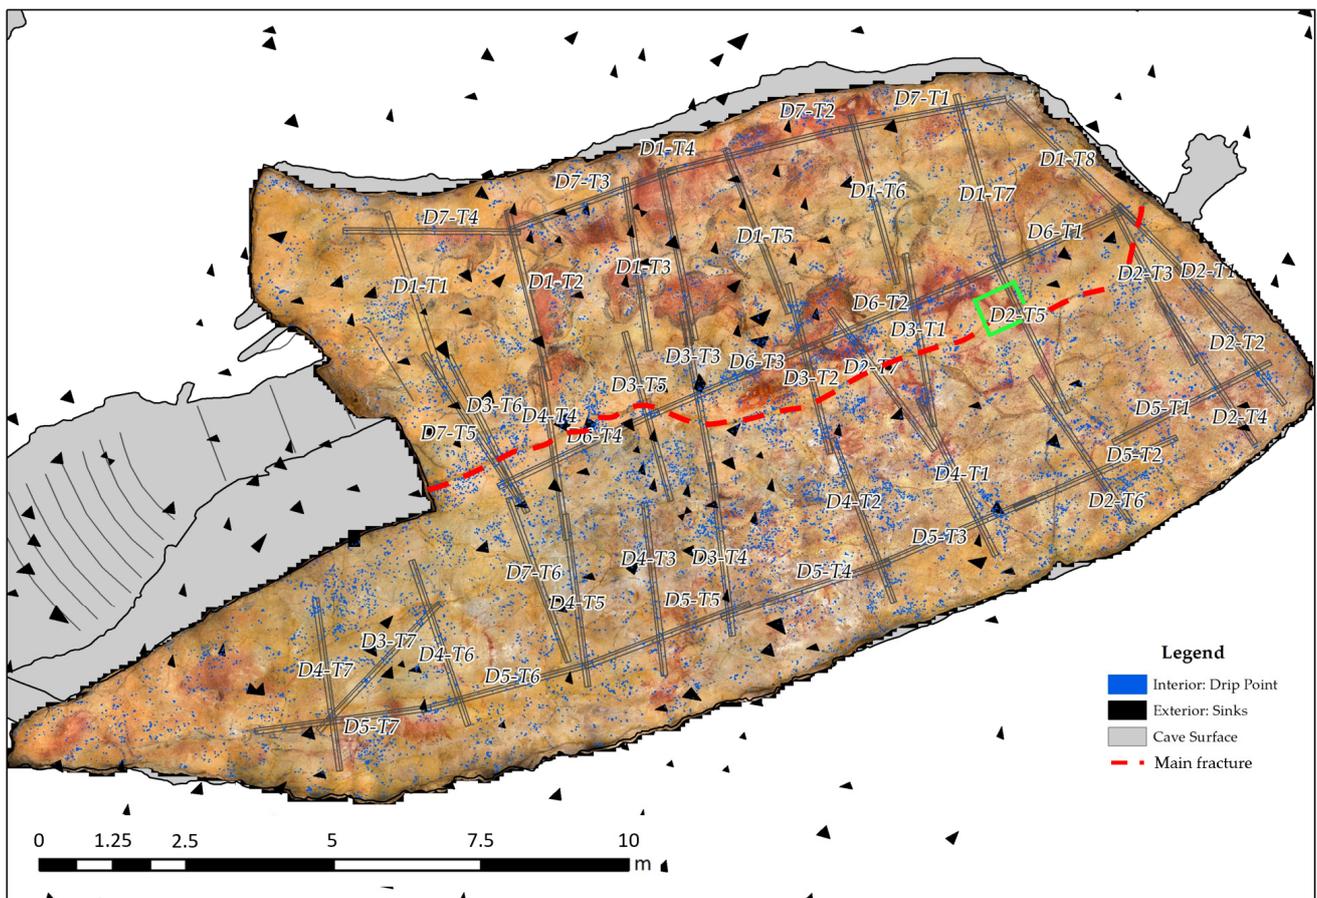
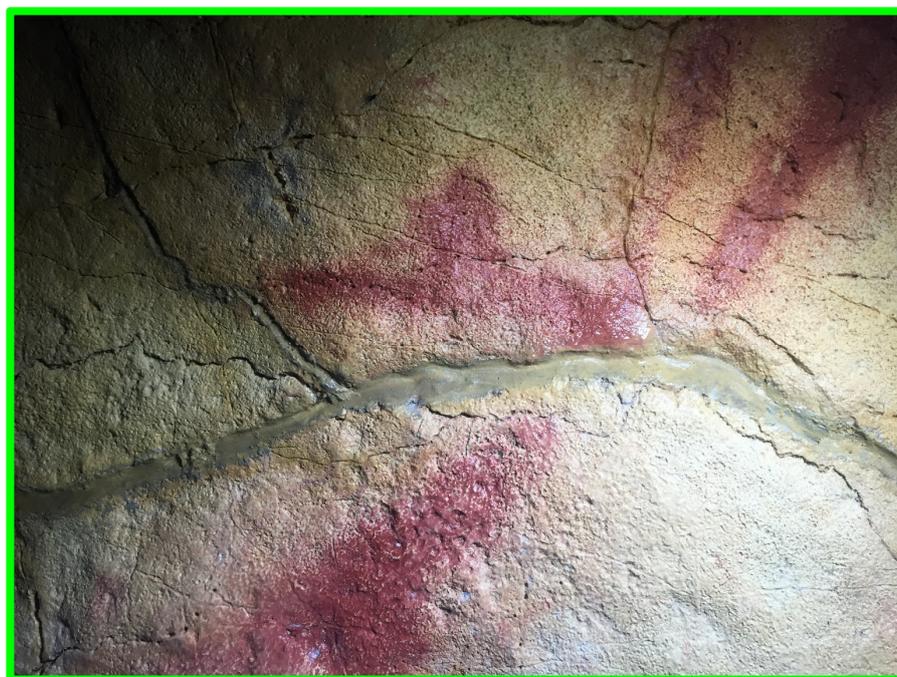
Figure 4. (a) Overlap of exterior sinks, interior drip points, position of the central fracture and position of the GPR profiles projected on the ceiling of the Polychrome Hall that were carried out with the 400 MHz and 900 MHz antennas. The green rectangle shows the position of (b) Image with detail of the central fracture sealed with mortar framed in green in (a).

Their layouts were transverse and parallel to the central longitudinal fracture (Figure 4a), taking into account the irregular relief of the ceiling and the displacement conditions of its interior. GPR data were collected with the antennas air-coupled to the ceiling of the Polychrome Hall in order to ensure that no contact occurred between the antennas and the ceiling. This was achieved by placing the antennas on a 3 m long traveling device. The GPR profiles were georeferenced using laser scanning.

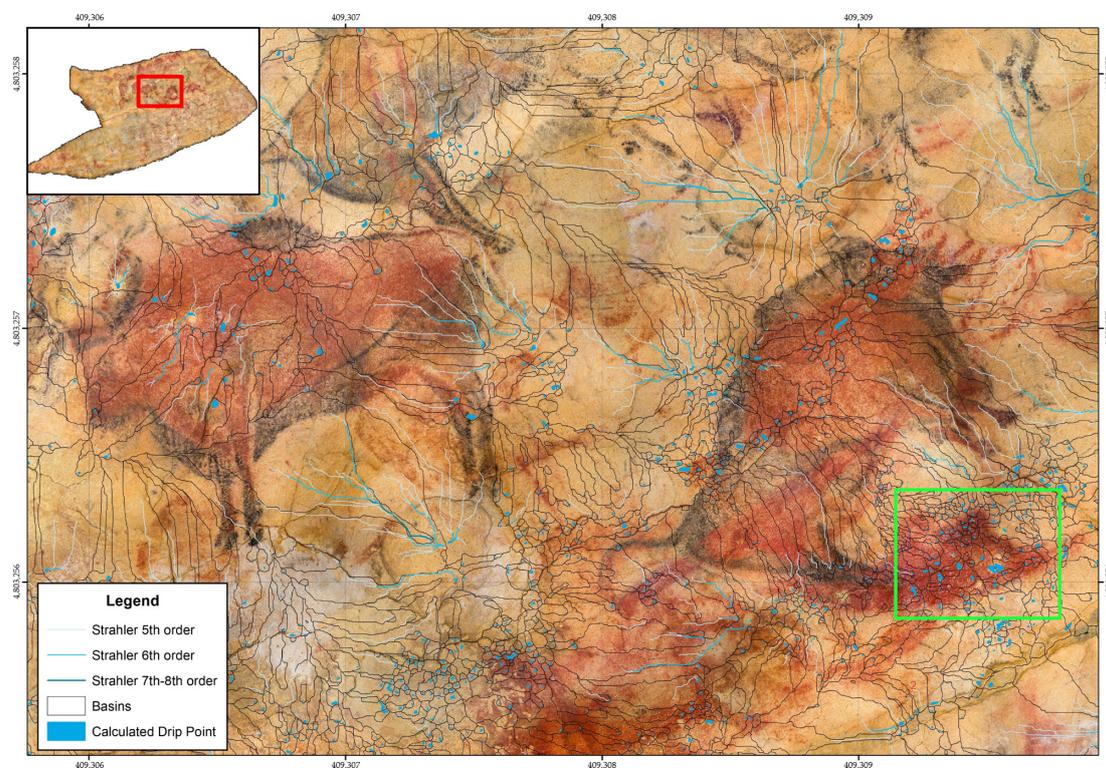
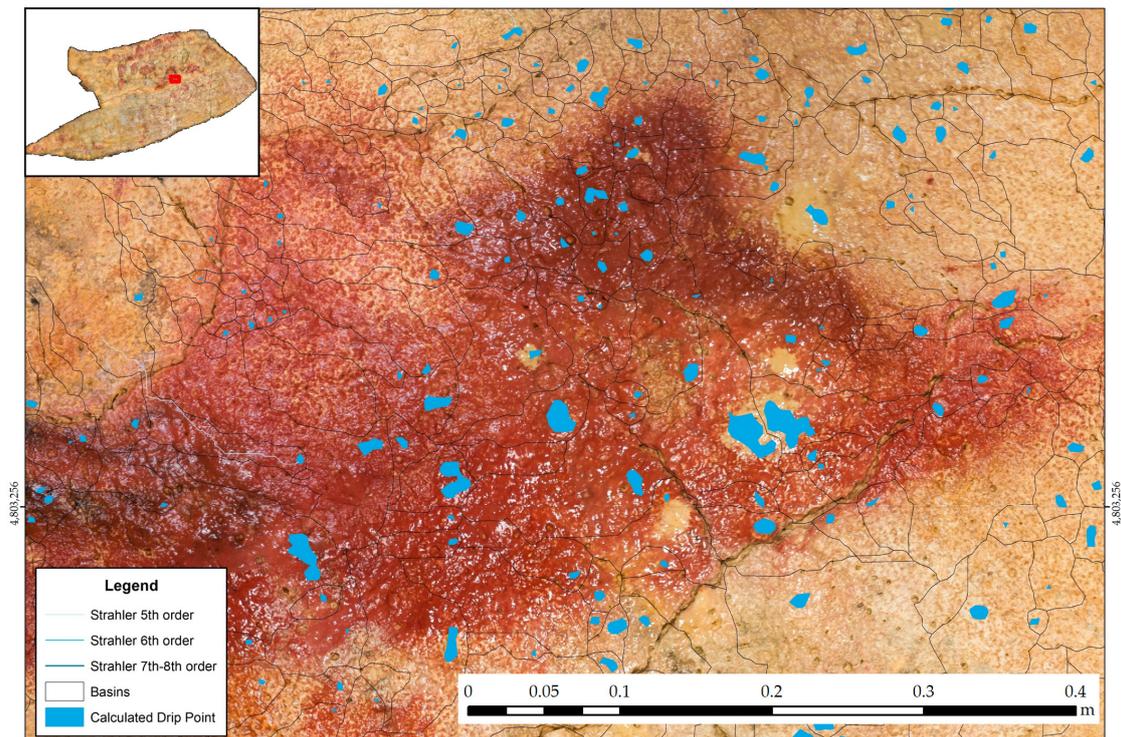
Figure 5. (a) Location of the ALT-1 active drip zone at the hind legs of the great bison figure (marked in a green rectangle). (b) Image with detail of the hind leg area of the great bison showing active drip points (indicated with blue polygons) and streams (indicated with blue lines). The thicker the blue lines (streams) the higher the hierarchy in the ALT-1 active drip zone.

The identification of the precise locations where water droplets will ultimately fall to the cave floor (Figure 5) has significant implications for cave conservation. Understanding the flow paths and points of ingress is important for predicting potential damage and degradation of rock paintings.

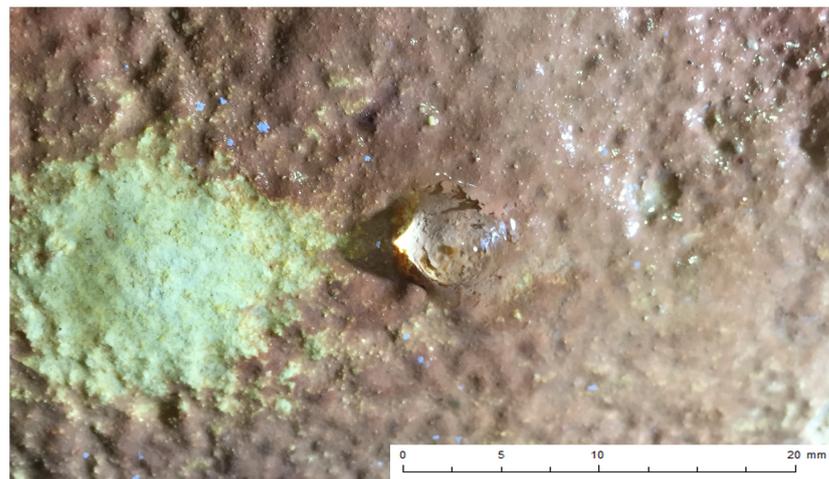
Figure 6. Detailed image of a sheet of water on Polychrome ceiling showing the surface tension of the water.

The workflow includes the same calculations as in Section 2.2, stream order analysis, basin delineation, and flow distance accumulation, but it now includes the calculation of the drip points. The identification of drip points is a key aspect of the analysis. Drip points are specific locations within the cave ceiling where accumulated water, driven by surface tension and capillary action, reaches a critical saturation point and eventually drips down to the cave floor. These drip points represent important features to map and understand, as they can have profound implications for rock art deterioration, cave formations, water quality, and ecological dynamics. (Figure 6).

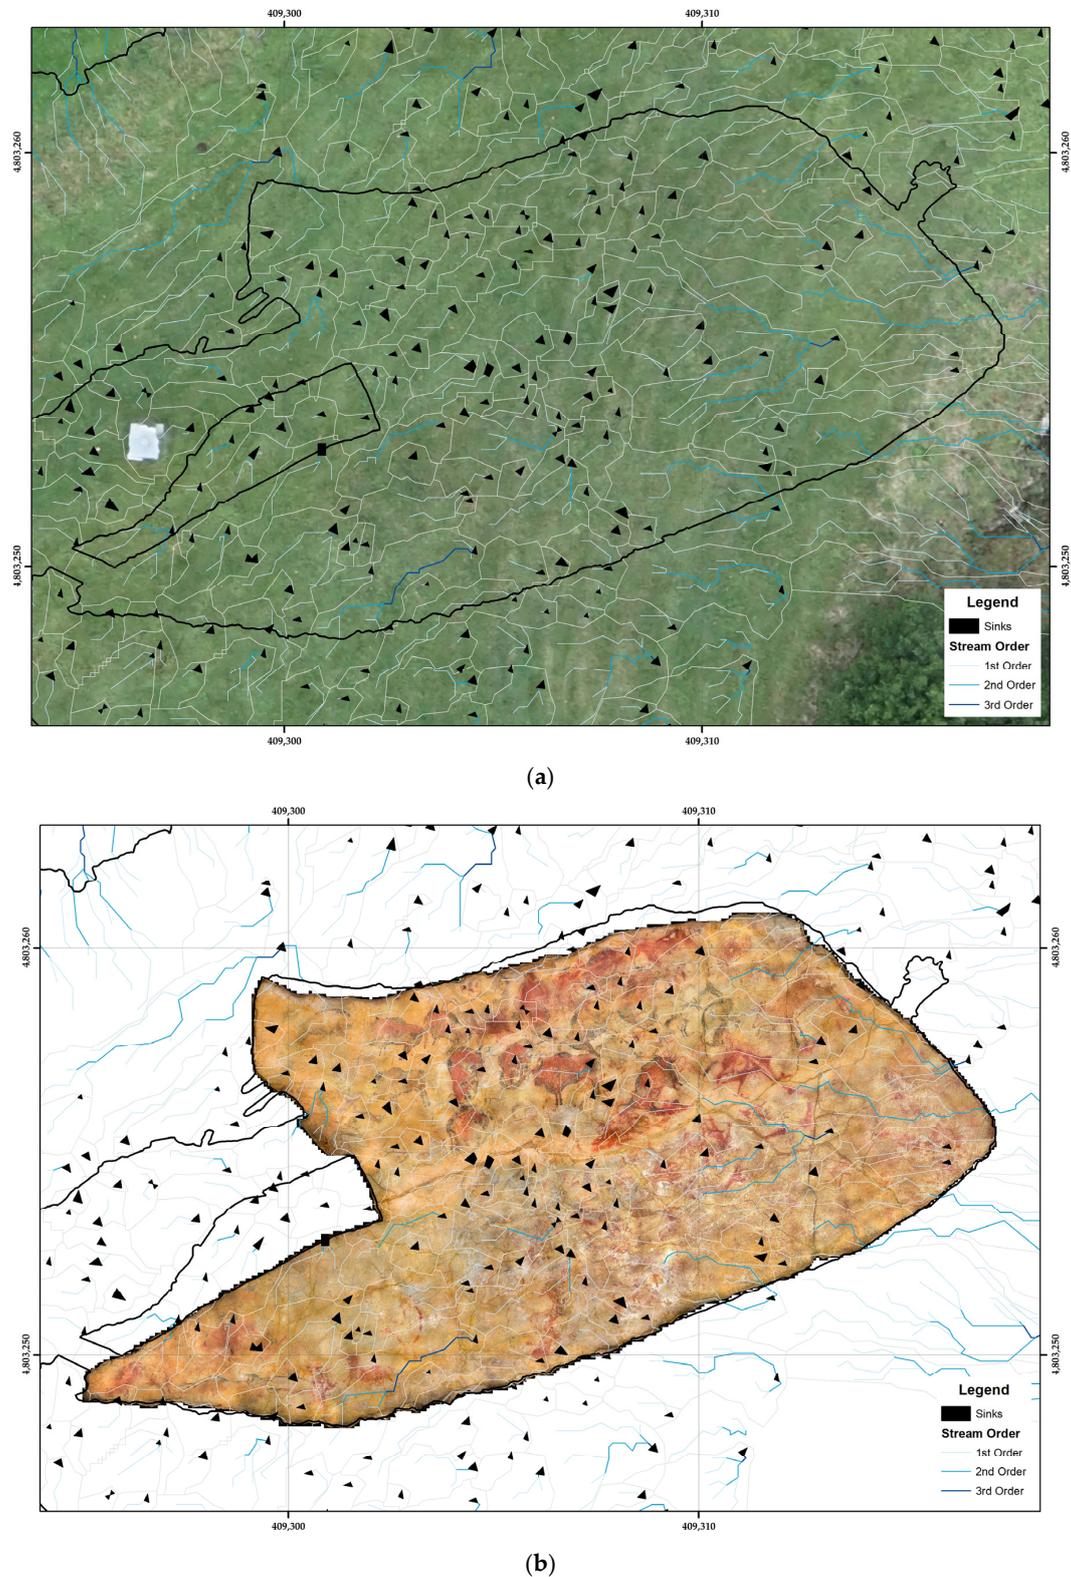
Figure 7. (a) Basins, sinks and classified streams according to the Strahler method [61] in the overlying layer of the Polychrome Hall; (b) Superimposition of the above results on the orthoimage of the Polychrome ceiling.

with a pixel size as fine as 2 cm has been used to make the calculations. This detailed imagery enables the calculation of sinks, streams, and contribution basins, providing a precise understanding of the surface area each basin encompasses (Figure 7).

Following the geospatial assessment, the obtained data are superimposed with the orthoimage of the Polychrome Hall (Figure 7b). This overlay allows for a nuanced examination, identifying sinks that correlate with surfaces affected by pigment migration and wash-out processes, distinguishing currently active sinks, and projecting potential future active sinks. This approach, combined with the systematic monitoring and follow-up to which we subject the affected areas with active dripping points of the Polychromes ceiling, puts us in a position to intuit the behavior of the water, pre-dictating and consequently anticipating possible damage to the paintwork.

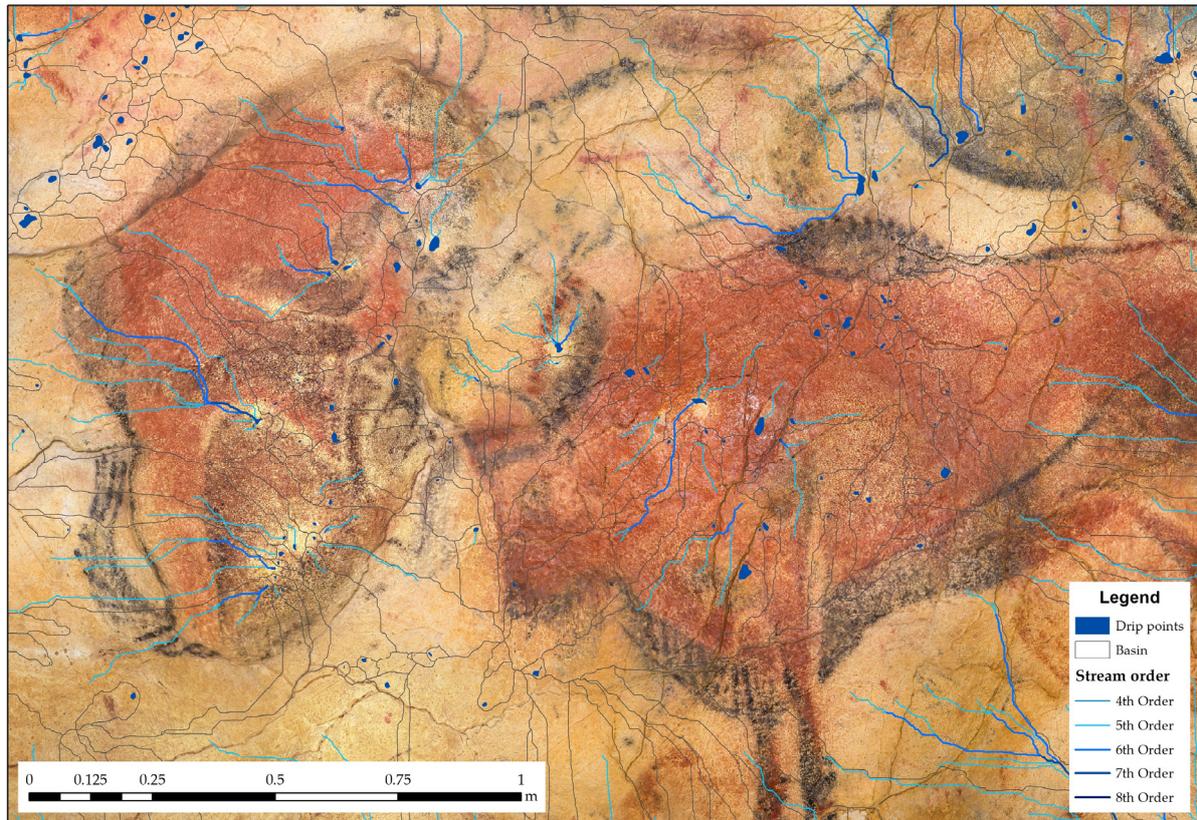
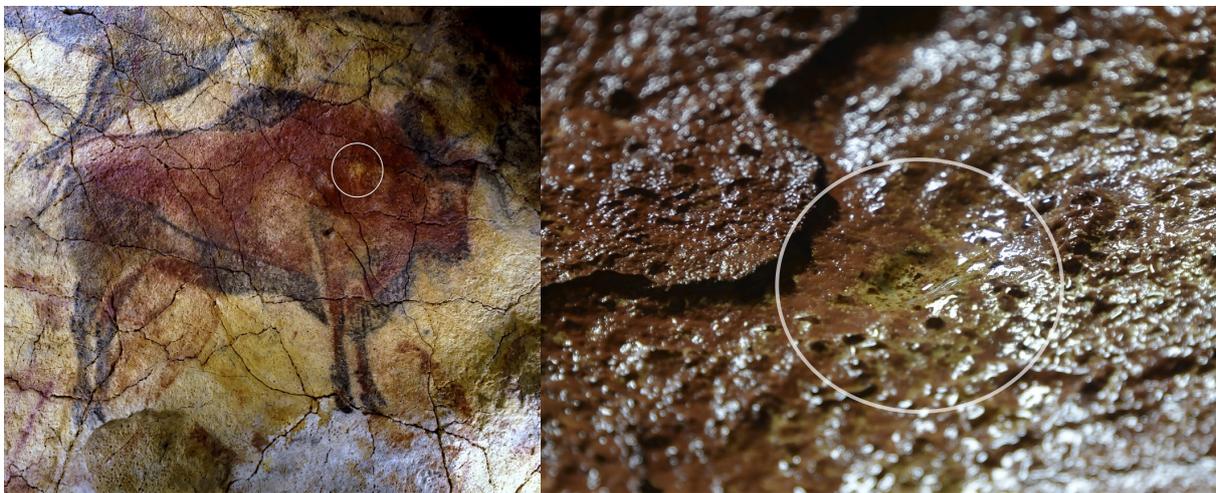
Figure 9. (a) Superimposition of basin, streams, drip points on orthoimage to check washed calculated points with real ones; (b) drip point located in the hump area or central part of the bison.

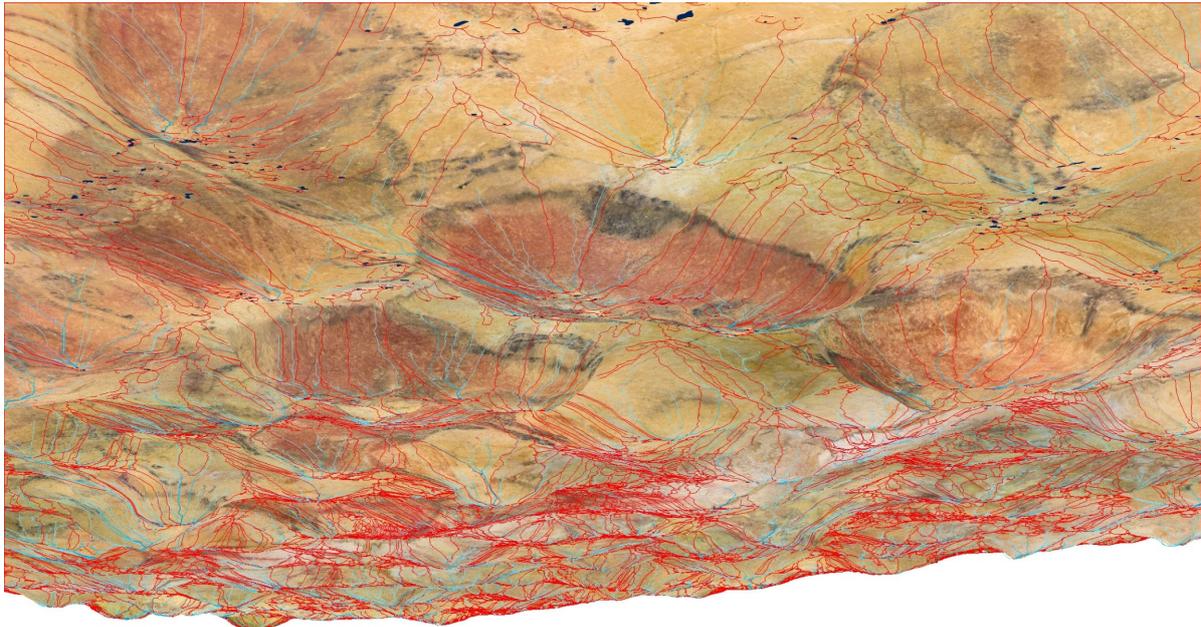
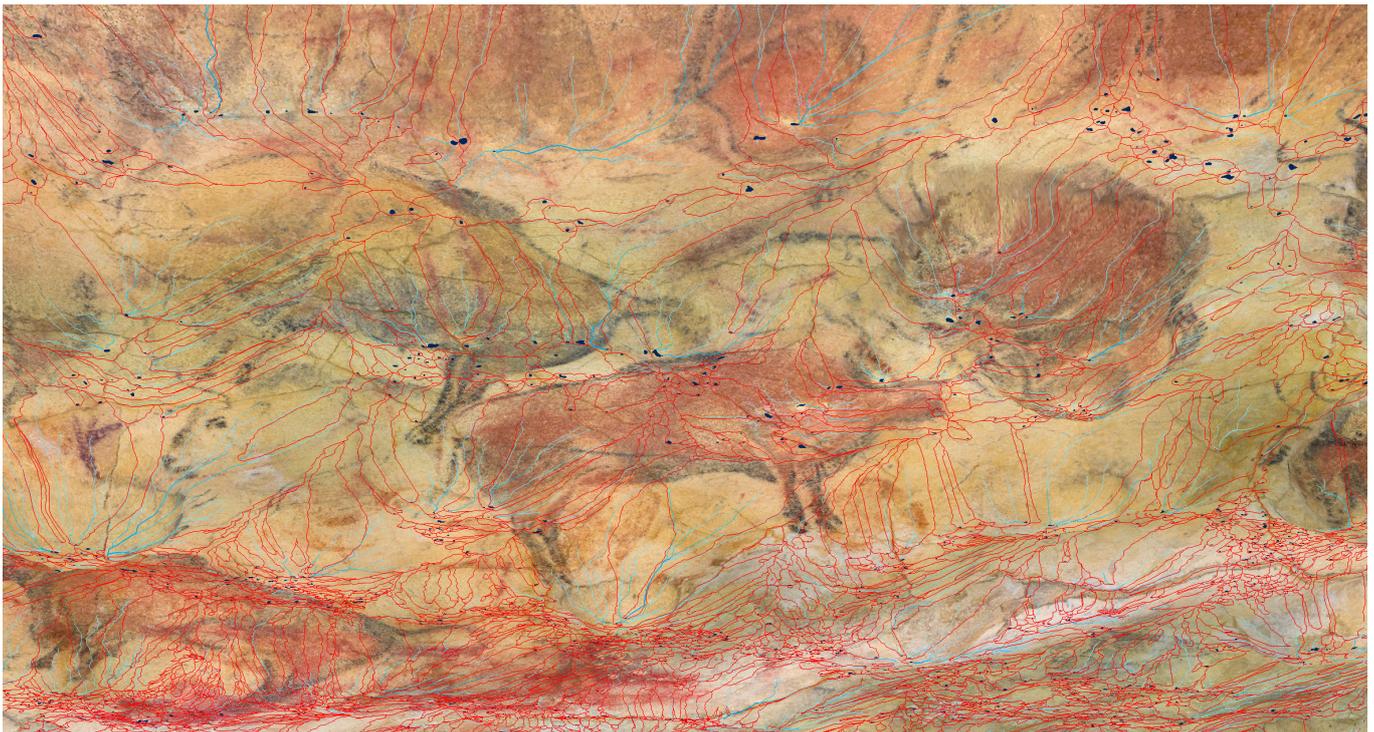
Figure 10. (a) General view of the 3D model of basins in Polychrome Hall ceiling showing the basins, streams and drip points; (b) Detail view of the model shown in Figure 9.

The significance of these hydrographic calculations extends beyond mere visualization, offering valuable information about the water distribution and pathways (Figure 10). Dripping points, which pinpoint areas where water ultimately reaches the ground, are important indicators of the hydrological behavior of the environment. This detailed analysis not only furthers our understanding of active cracks and water channels but also sheds light on the specific locales where water interacts with the cave floor, informing broader insights into the geological processes at play in the studied area.

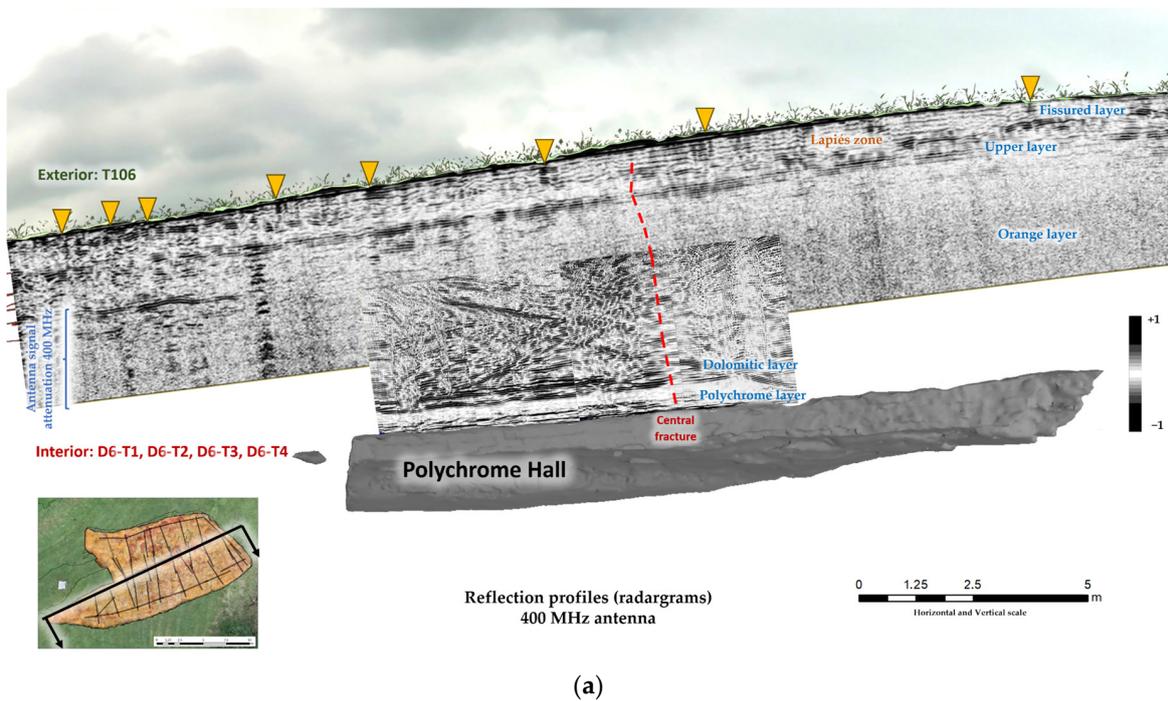
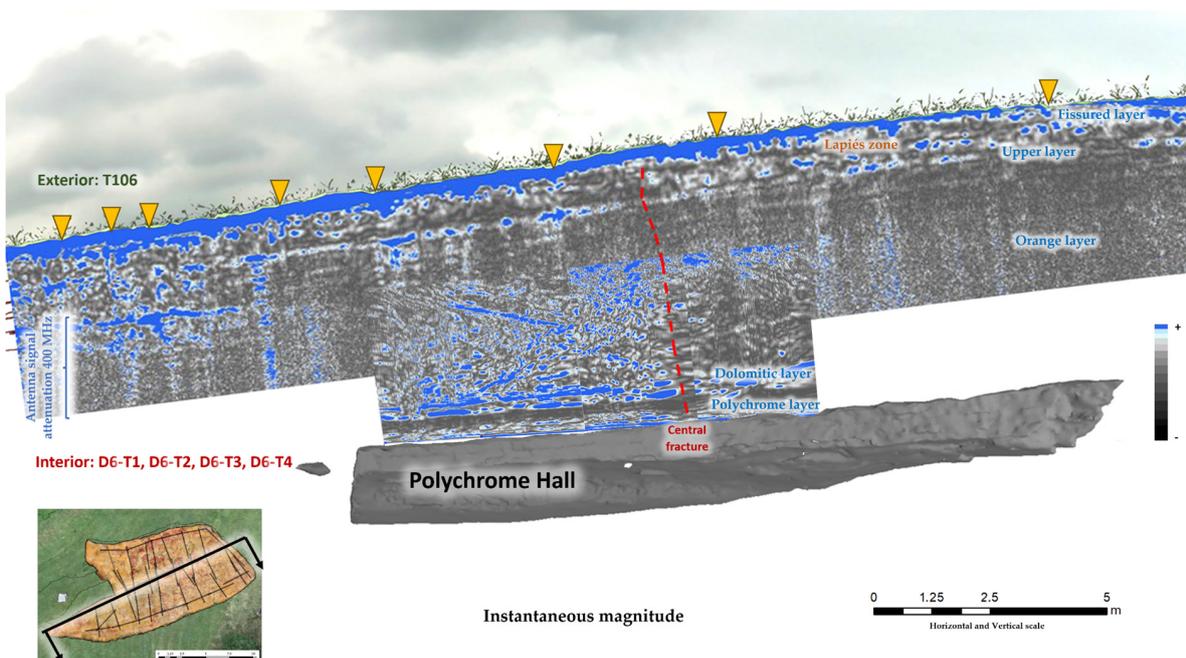
Figure 11. (a) Cross section showing the main vertical discontinuities in the overlying Polychrome Hall layer obtained by precise georeferencing of the inner reflection profiles D6-T1, D6-T2, D6-T3 and D6-T4 and the outer reflection profile T106; (b) Cross section with the instantaneous magnitude attribute derived from these reflection profiles shows the main areas of moisture/water infiltration or water pathways in the overlying Polychrome Hall layer. The central fracture can be seen to run from the lapiés zone (fissured layer) to the basal surface of the Polychrome layer (indicated by the red dashed line). The surface sinks coinciding with or close to the layout of these reflection profiles have been plotted (indicated by ochre triangles). Also shown are the signal attenuation zone with the 400 MHz antenna and the correlation of the reflection profiles with the stratigraphic units of the overlying layer of the Polychrome Hall.

The standard GPR interpretation method successfully identifies discontinuities in the overlying Polychrome Hall layer; however, it may not be effective in recognizing areas of moisture/water prone to seepage or waterways (Figure 11a). Therefore, the use of the Hilbert transform to the obtained radar signal to extract attributes has improved the identification of the inherent properties of the geological materials of the overlying Polychrome Hall layer, as the instantaneous magnitude attribute to identify areas of moisture/water potential for seepage or waterways (Figure 11b).

As shown in Figure 11, the presence of these moisture zones is mainly related to two lateral sources (Figure 11a): one on the south side clearly associated with the large central fracture (dashed red line), and another on the north side from a fracture of similar length to the central one, which even begins at a higher level (almost one meter from the surface). This vertical fracture reaches almost the surface of the ceiling of the Polychrome Hall at the great bison's belly and hind legs, which are located in the active drip zone ALT1 (Figure 5). This moisture zone clearly comes from higher elevations. In addition, it is related to a central fracture (indicated by the red dashed line) and to the seepage of water flowing down the northwest-southeast dip (Figure 11b). This is corroborated by analyzing the photogrammetry images of the ceiling surface taken in the active drip zone ALT1. In this active drip zone ALT1 with pigment fall, water flowing is observed, which carries pigments through a series of fractures and fissures that seem to run in favor of the ceiling dip. Likewise, the moisture sources described above are also the same for the belly area of the great bison.
